**Flood Control Project Maintenance
Levee Inspections**
LMA District Cover Sheet
Spring 2017 Levee Inspection Results

City of Sacramento

Spring 2017 Levee Inspection Results

Waterway			Bank	Unit Miles
Unit No. 01 Sacramento River			Left	3.67
	Spring (March - May)	Summer (June - August)	(September - November) Fall	Winter (December - February)
Unit Maintenance Rating (Fall Only)				
Date of Inspection	3/29/2017 - 3/29/2017			
DWR Inspector	Zach Jojola			
Accompanied By	Dan Velez City of Sacramento

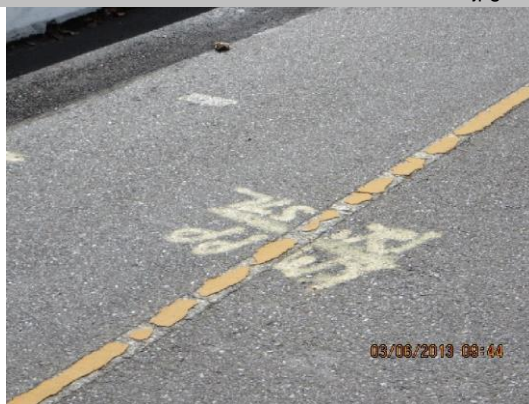
Photo 3 of 3 : UCIP_SP_2017_49955_33807.jpg

Underground service alert (USA) markings indicate 12 inch crossing through levee.

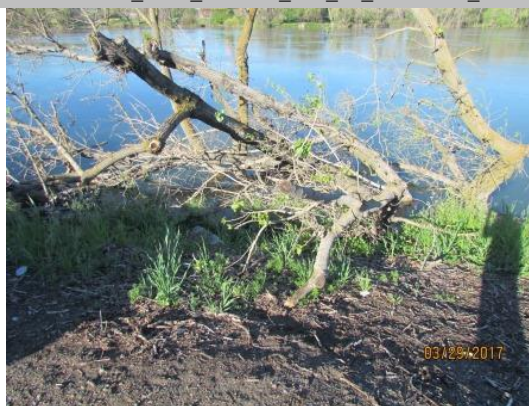
Photo 1 of 1 : SP_2017_NA0005_251_79_20170414_00138.jpg

Fallen tree limbs on the waterside levee slope, looking toward the Sacramento River. Spring 2017.

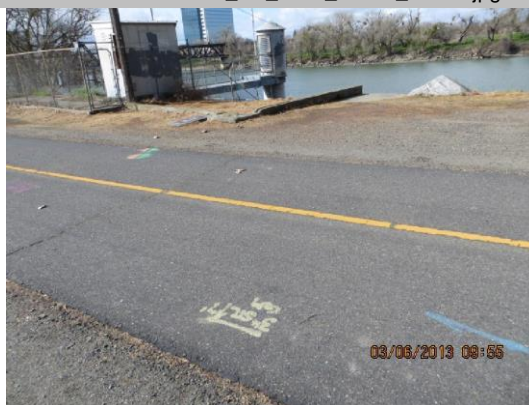
Photo 1 of 3 : UCIP_SP_2017_41414_72622.jpg

LM Start	0.14	Rating **	M	Issue No.	103
LM End	0.14	Issue Type +	En	Location *	WS
Category	Supplemental			GPS Latitude/Longitude	
				Start	End
Item	DWR UCIP Field Study			38.588768 °	38.588768 °
				-121.504891 °	-121.504891 °
DWR ID					
Comment Code					
Inspector Comment					
FS_ID:41414					
DS_ID:24882					
EP_NO: N/A					
Repair Type: Non-Urgent					
Crossing Status: Indicator Found					
UCIP Comments: Need to contact owner to determine status of crossing. No permit found during desk study review.					
FIELD_STRUCT_DESC: 42 inch water transmission main through levee at unknown depth. Crossing installed in 1966.					
FS Date: 3/6/2013

View of levee crown and waterward side.

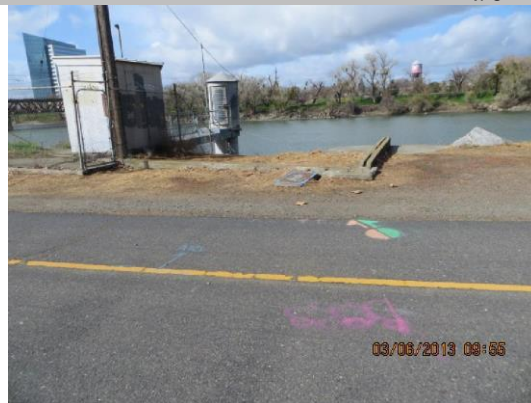
Photo 2 of 3 : UCIP_SP_2017_41414_72621.jpg

LM Start	0.14	Rating **	M	Issue No.	103 (cont)	
LM End	0.14	Issue Type +	En	Location *	WS	
Category	Supplemental			GPS Latitude/Longitude		
				Start	End	
Item	DWR UCIP Field Study			38.588768 °	38.588768 °	
				-121.504891 °	-121.504891 °	
DWR ID						
Comment Code						
Inspector Comment						
FS_ID:41414						
DS_ID:24882						
EP_NO: N/A						
Repair Type: Non-Urgent						
Crossing Status: Indicator Found						
UCIP Comments: Need to contact owner to determine status of crossing. No permit found during desk study review.						
FIELD_STRUCT_DESC: 42 inch water transmission main through levee at unknown depth. Crossing installed in 1966.						
FS Date: 3/6/2013

Underground Service Alert (USA) markings indicating 42 inch line through levee.

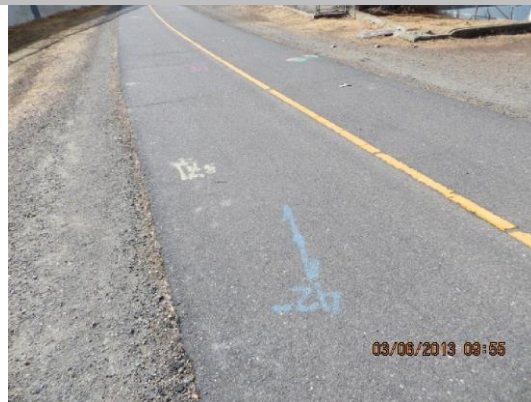
Photo 3 of 3 : UCIP_SP_2017_41414_72620.jpg

View of alignment along levee.

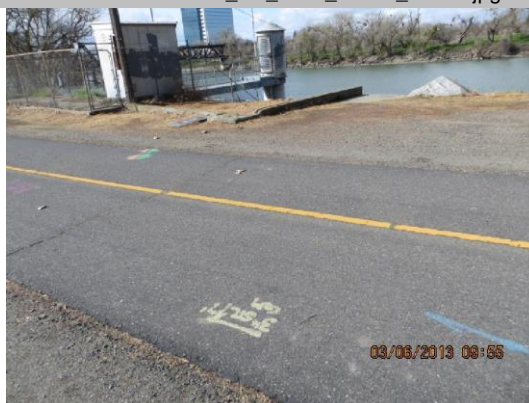
Photo 1 of 2 : UCIP_SP_2017_41415_72630.jpg

LM Start	0.14	Rating **	M	Issue No.	104
LM End	0.14	Issue Type +	En	Location *	WS
Category	Supplemental			GPS Latitude/Longitude	
				Start	End
Item	DWR UCIP Field Study			38.588738 °	38.588738 °
				-121.504891 °	-121.504891 °
DWR ID					
Comment Code					
Inspector Comment					
FS_ID:41415 DS_ID:24883 EP_NO: N/A Repair Type: Non-Urgent Crossing Status: Indicator Found UCIP Comments: Need to contact owner to confirm alignment and status of crossings. No permit found during desk study review. FIELD_STRUCT_DESC: ARV communication line and 3-inch STL communication line on levee. FS Date: 3/6/2013

Underground Service Alert (USA) markers visible on levee crown.

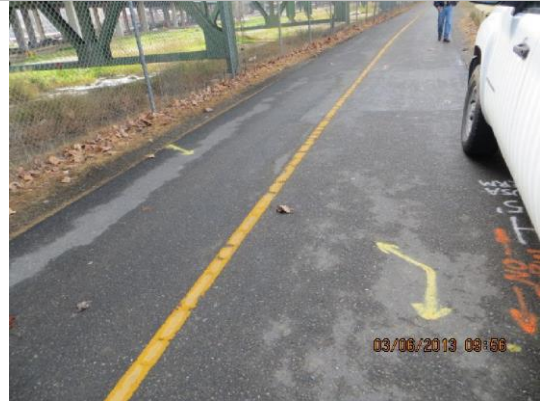
Photo 3 of 3 : UCIP_SP_2017_49956_72625.jpg

Item	DWR UCIP Field Study			38.588636 °		38.588636 °
				-121.504860 °		-121.504860 °
DWR ID						
Comment Code						
Inspector Comment						
FS_ID:49956 DS_ID:24884 EP_NO: N/A Repair Type: Urgent Crossing Status: Indicator Found UCIP Comments: 07/19/2016 same as previous inspection. Need to contact owner to determine status of crossing. Unable to confirm alignment or depth through the levee crown. (DWR UCIP - omagana)10/17/2014 No markers found. Need to contact owner to determine status of crossing and to determine last inspection date. (DWR UCIP - omagana) FIELD_STRUCT_DESC: 3-inch steel gas line though levee at unknown depth. Underground alert service (USA) markings indicate this line is a PG&E line visible in 2013. FS Date: 7/19/2016

Underground Service Alert (USA) markings of PG&E line through levee, Photo 2 of 2.

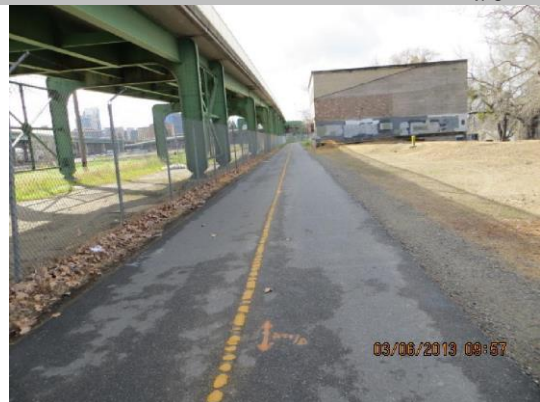
Photo 1 of 2 : UCIP_SP_2017_41416_72629.jpg

LM Start	0.16	Rating **	M	Issue No.	106
LM End	0.16	Issue Type +	En	Location *	WS
Category	Supplemental			GPS Latitude/Longitude	
				Start	End
Item	DWR UCIP Field Study			38.588500 °	38.588500 °
				-121.504856 °	-121.504856 °
DWR ID					
Comment Code					
Inspector Comment					
FS_ID:41416 DS_ID:24885 EP_NO: N/A Repair Type: Non-Urgent Crossing Status: Indicator Found UCIP Comments: No markers visible as per Title 23. Recommend having utility owner coordinate with Central Valley Flood Protection Board (CVFPB). FIELD_STRUCT_DESC: ATT communication line through levee at unknown depth. FS Date: 3/6/2013

Alignment of communication line through levee, Photo 1 of 2.

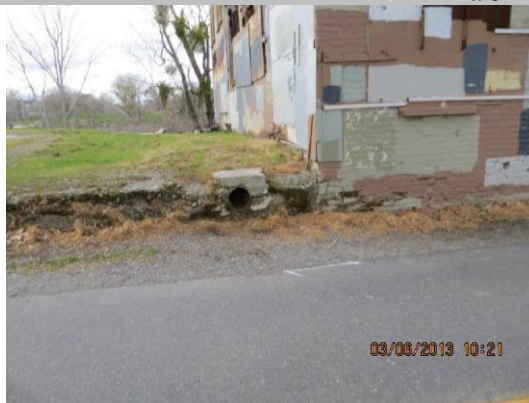
Photo 1 of 3 : UCIP_SP_2017_40848_72633.jpg

LM Start	0.22	Rating **	M	Issue No.	108
LM End	0.22	Issue Type +	En	Location *	WS
Category	Supplemental			GPS Latitude/Longitude	
				Start	End
Item	DWR UCIP Field Study			38.587615 °	38.587615 °
				-121.505034 °	-121.505034 °
DWR ID					
Comment Code					
Inspector Comment					
FS_ID:40848					
DS_ID:24887					
EP_NO: N/A					
Repair Type: Non-Urgent					
Crossing Status: Indicator Found					
UCIP Comments: Pump station appears non-functional. Owner will need to coordinate with DWR-Inspector and CVFPB to determine if crossing meets Title 23 requirements.					
FIELD_STRUCT_DESC: 12 inch connected to 10 inch pipe through levee at unknown depth.					
FS Date: 3/6/2013

Pipe through levee visible next to building located on levee.

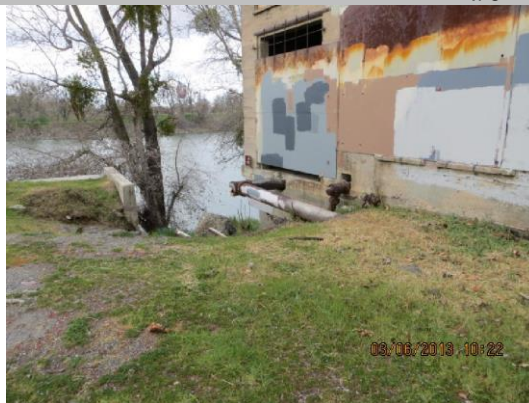
Photo 3 of 3 : UCIP_SP_2017_40848_72631.jpg

View of building and additional concrete structures located on levee crown at waterward side.

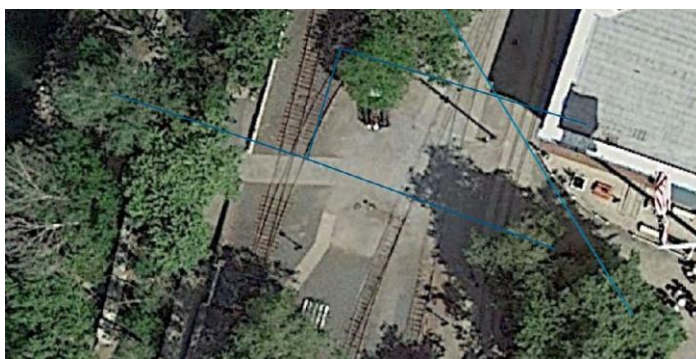
Photo 1 of 1 : UCIP_SP_2017_41247_72740.jpg

LM Start	0.42	Rating **	M	Issue No.	109
LM End	0.42	Issue Type +	En	Location *	WS
Category	Supplemental			GPS Latitude/Longitude	
				Start	End
Item	DWR UCIP Field Study			38.584794 °	38.584794 °
				-121.505548 °	-121.505548 °
DWR ID					
Comment Code					
Inspector Comment					
FS_ID:41247					
DS_ID:24889					
EP_NO: N/A					
Repair Type: Non-Urgent					
Crossing Status: Indicator Found					
UCIP Comments: Unable to confirm if crossing exists. Approximate alignment provided by the City of Sacramento. Need to confirm alignment and status of crossing.					
FIELD_STRUCT_DESC: 10 inch pipe through levee. Record was obtained from Sacramento County approximate utility alignment.					
FS Date: 3/6/2013

Alignment provided by City of Sacramento of 10 inch line--not found during field inspection.

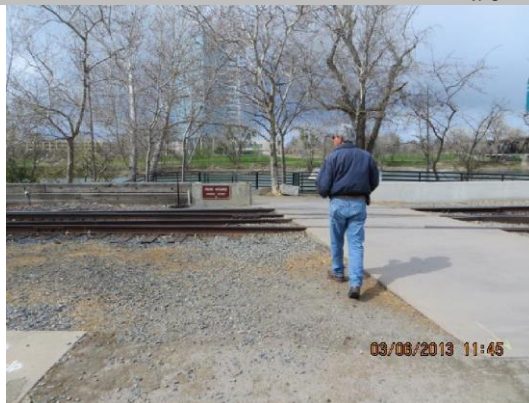
Photo 1 of 3 : UCIP_SP_2017_20384_34410.jpg

LM Start	0.42	Rating **	M	Issue No.	110
LM End	0.42	Issue Type +	En	Location *	WS
Category	Supplemental			GPS Latitude/Longitude	
				Start	End
Item	DWR UCIP Field Study			38.584762 °	38.584762 °
				-121.505556 °	-121.505556 °
DWR ID					
Comment Code					
Inspector Comment					
FS_ID:20384					
DS_ID:21561					
EP_NO: N/A					
Repair Type: Non-Urgent					
Crossing Status: Indicator Found					
UCIP Comments: Only manhole was visible; need to determine condition of crossing; Will need to follow up with the City of Sacramento.					
FIELD_STRUCT_DESC: 18-inch-diameter storm drain through the levee, 5 feet below the crown. Concrete surge box on the waterward side of the retaining wall. Concrete box spillway.					
FS Date: 3/6/2013

View of levee crown downtown Sacramento--wide crown with railroad.

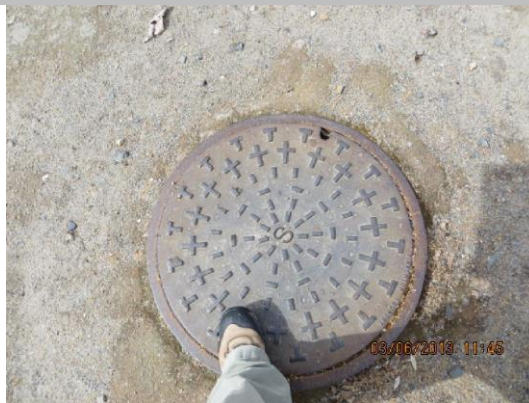
Photo 2 of 3 : UCIP_SP_2017_20384_34409.jpg

View of manhole located at the edge of waterward.

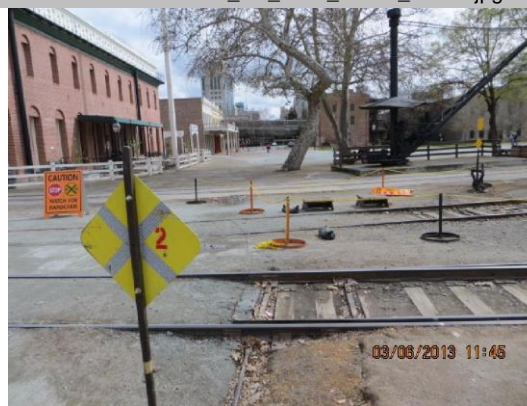
Photo 3 of 3 : UCIP_SP_2017_20384_34408.jpg

View of landward side close to railroad museum.

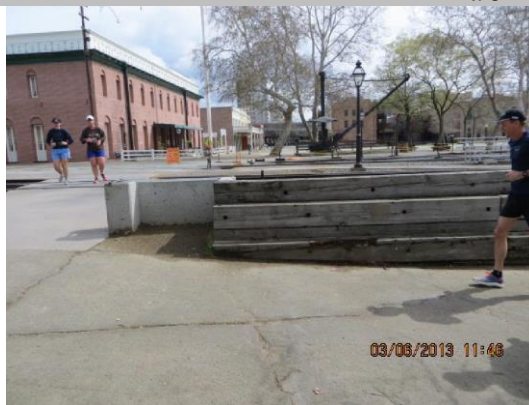
Photo 3 of 3 : UCIP_SP_2017_41417_72640.jpg

View of landward side.

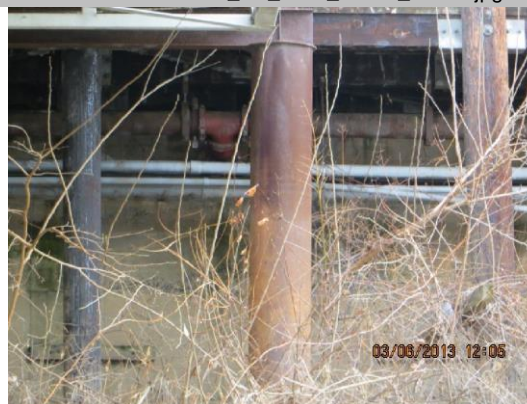
Photo 1 of 1 : UCIP_SP_2017_41438_72745.jpg

View of crossing visible from waterward side looking at floodwall.

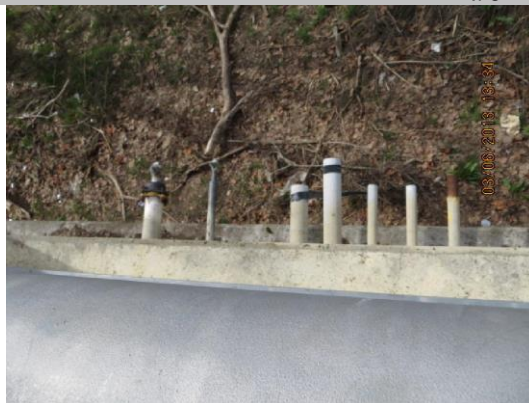
Photo 2 of 3 : UCIP_SP_2017_41422_72753.jpg

Conduits through floodwayll.

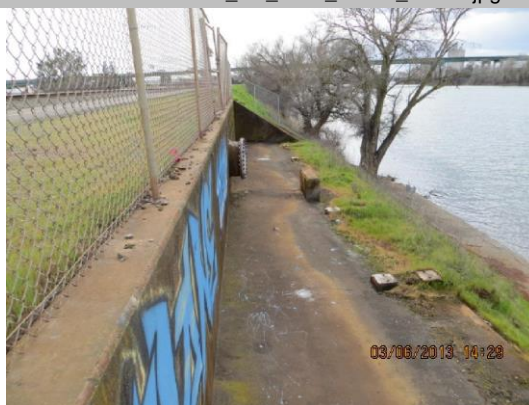
Photo 2 of 3 : UCIP_SP_2017_41425_34144.jpg

Headwall with 1 crossing capped off.

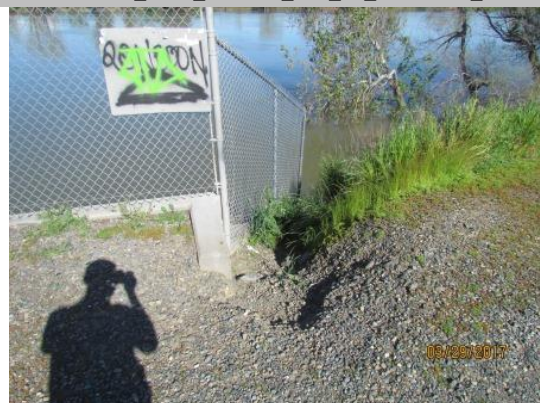
Photo 1 of 1 : SP_2017_NA0005_251_87_20170414_00142.jpg

Foot path digging into waterside levee slope. Spring 2017.

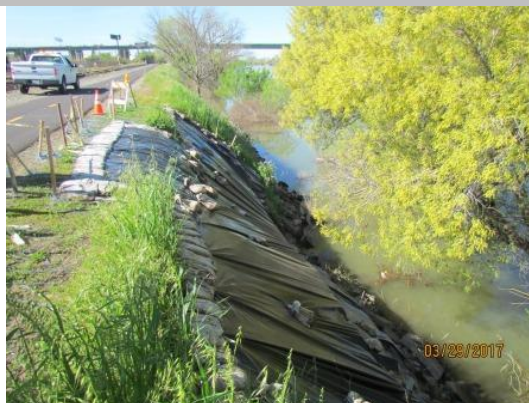
Photo 1 of 1 : SP_2017_NA0005_251_90_20170414_00144.jpg

Sloughing site on waterside levee slope from January high water event. Sloughing on waterside levee slope staked during January high water event. City of Sacramento placed envelope to prevent further erosion from occurring. Spring 2017.

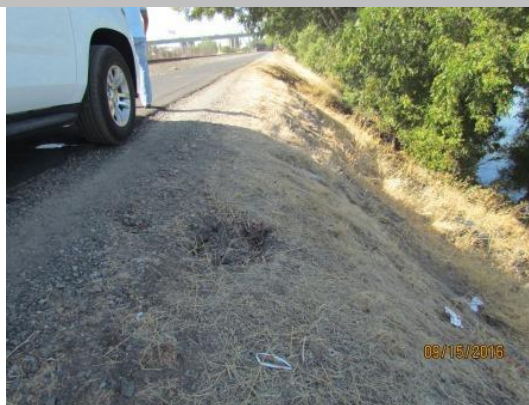
Photo 2 of 2 : SP_2017_NA0005_251_76_20170320_00015.jpg

Rodent hole backfilled with natural soil on waterward side of the levee. Fall 2016 inspection.

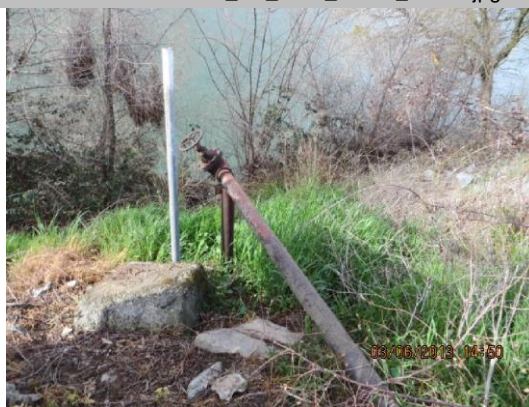
Photo 2 of 2 : UCIP_SP_2017_49767_34066.jpg

View of pipe and gate valve located on waterward slope.

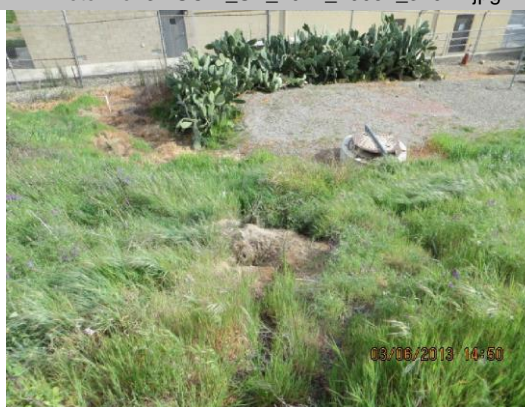
Photo 2 of 3 : UCIP_SP_2017_49957_34072.jpg

View of landward side--tall grass along slope limit inspection.

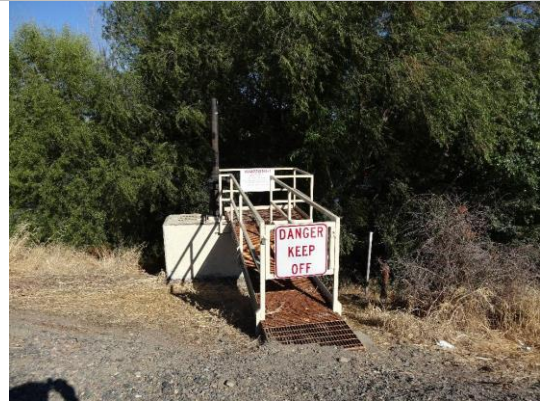
Photo 3 of 3 : UCIP_SP_2017_49957_75769.jpg

View of WS--gate inside concrete structure.

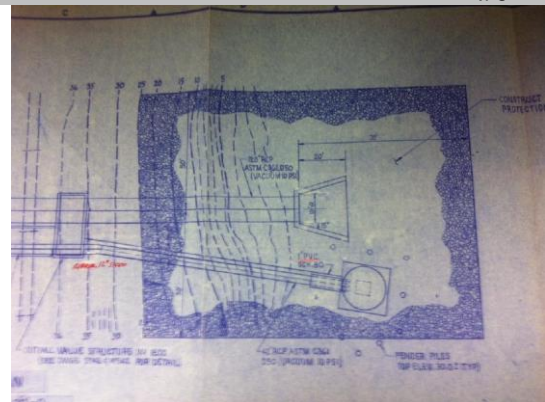
Photo 2 of 3 : UCIP_SP_2017_49778_34027.jpg

Rip rap protection around outfall structure for 42-inch and 120-inch pipes.

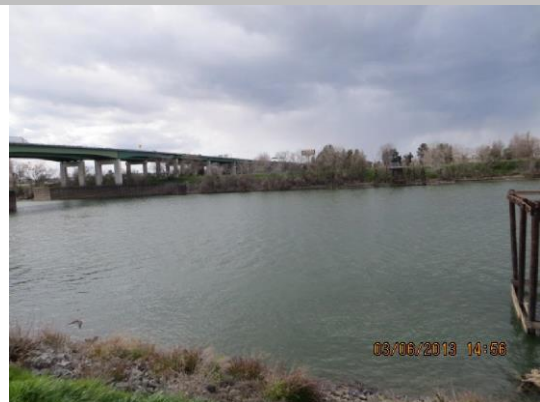
Photo 2 of 3 : UCIP_SP_2017_49958_34050.jpg

View of waterward side--outlet submerged.

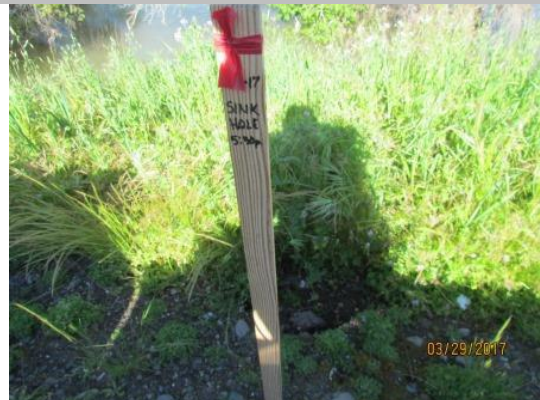
Photo 1 of 1 : SP_2017_NA0005_251_88_20170414_00143.jpg

Sink hole on waterside levee slope near crown. Spring 2017.

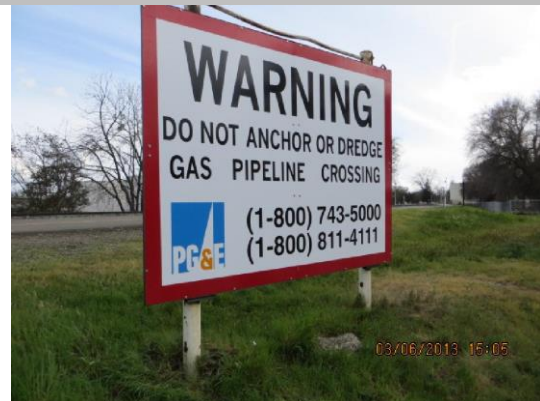
Photo 1 of 3 : UCIP_SP_2017_32883_59502.jpg

PG&E warning gas line crossing--waterward side view.

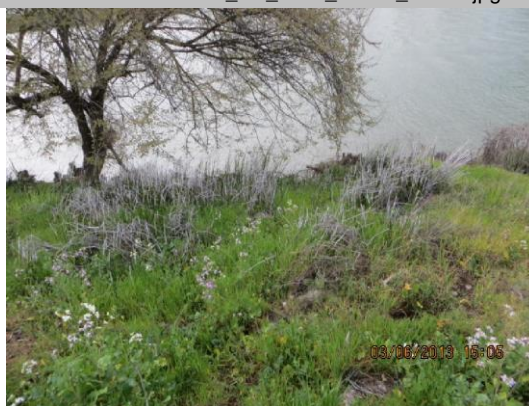
Photo 2 of 3 : UCIP_SP_2017_32883_59501.jpg

View of waterward slope--tall grass limits inspection.

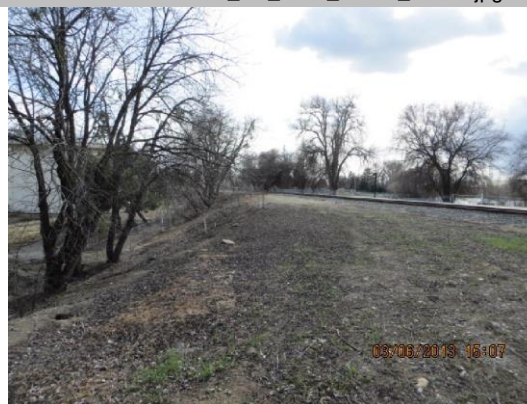
Photo 1 of 3 : UCIP_SP_2017_41442_59560.jpg

View of crossing approximately 110 feet downstream--stand pipes located on landward shoulder.

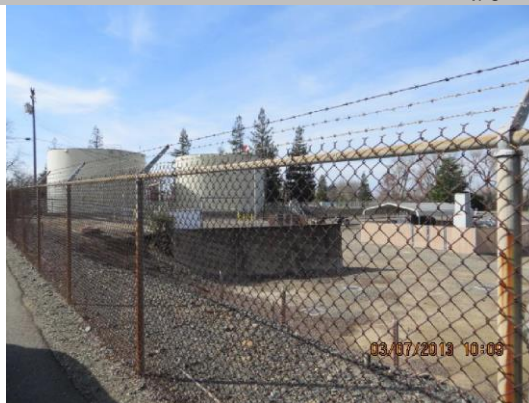
Photo 1 of 1 : UCIP_SP_2017_41444_59572.jpg

Concrete structure still remain in lot on waterward side.

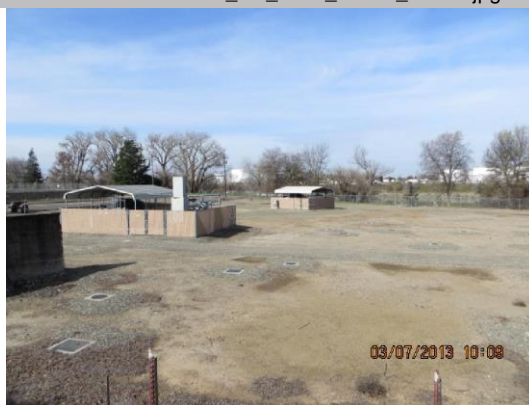
Photo 2 of 3 : UCIP_SP_2017_41282_59574.jpg

Several vapor wells present inside fenced area.

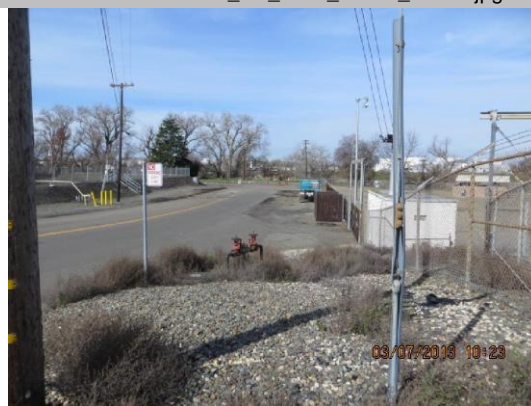
Photo 2 of 3 : UCIP_SP_2017_41427_59506.jpg

Backflow prevention device on shoulder.

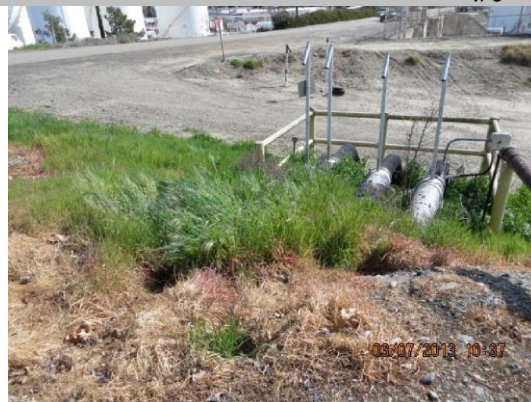
Photo 2 of 3 : UCIP_SP_2017_41452_59524.jpg

Dense burrow activity along landward slope.

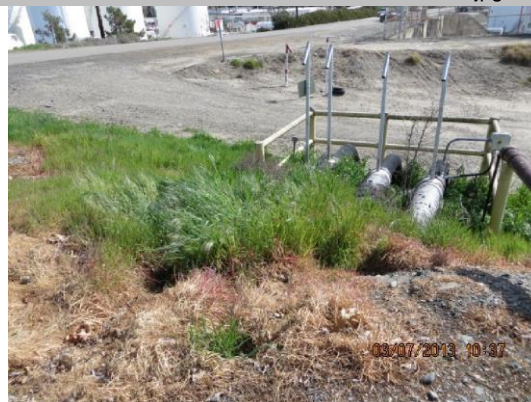
Photo 3 of 3 : UCIP_SP_2017_41448_59512.jpg

Dense vegetation and large burrow holes located on shoulder.

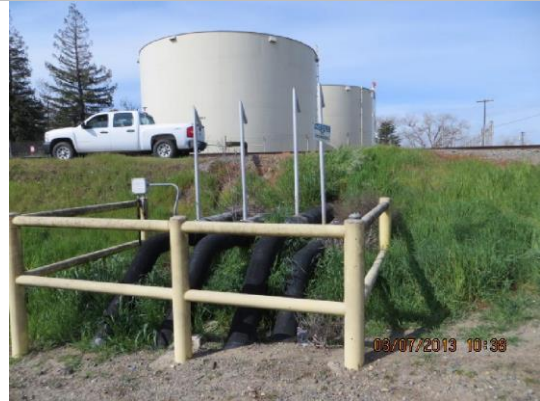
Photo 3 of 3 : UCIP_SP_2017_41449_59516.jpg

Pipes protected by metal post fence--landward side.

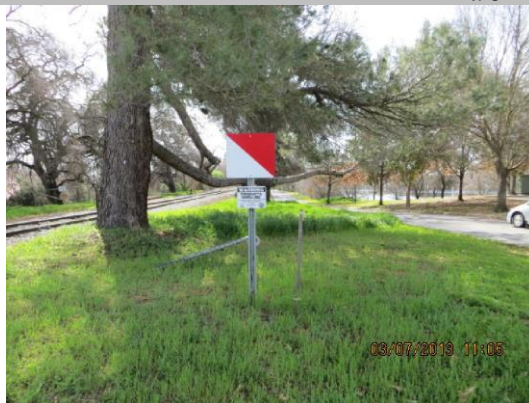
Photo 1 of 1 : UCIP_SP_2017_41291_72758.jpg

Marker of gas line visible on levee crown next to railroad tracks.

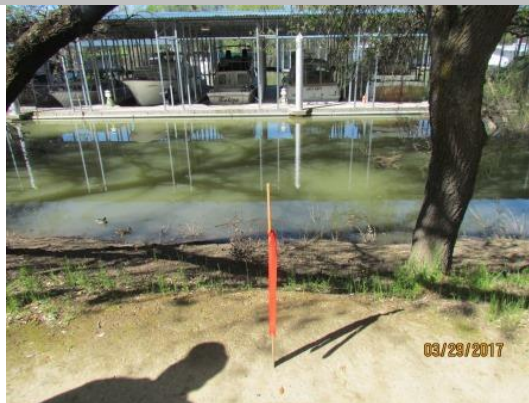
Photo 1 of 1 : SP_2017_NA0005_251_86_20170414_00147.jpg

Erosion on wateside slope that appers to be underwater. Marked on March 17, 2017. Spring 2017.

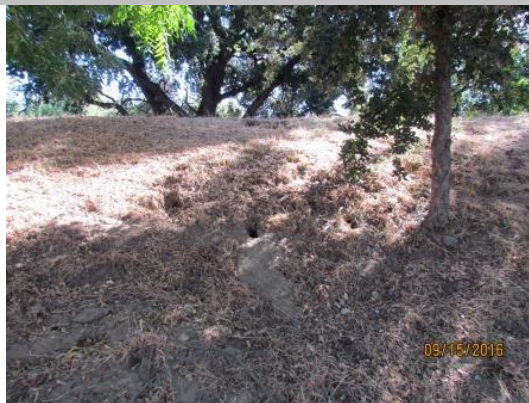
Photo 1 of 1 : SP_2017_NA0005_251_77_20170320_00016.jpg

More squirrel holes found on waterward slope. Fall 2016.

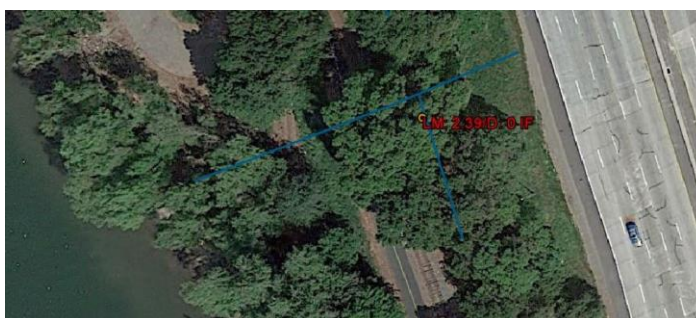
Photo 1 of 1 : UCIP_SP_2017_41433_72801.jpg

Approximate alignment for crossing provided by City of Sacramento GIS.

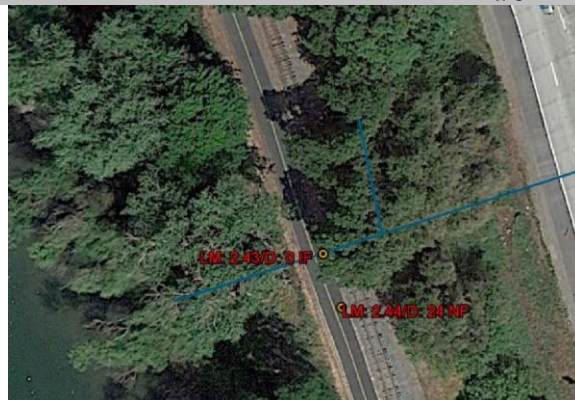
Photo 1 of 1 : UCIP_SP_2017_41296_72767.jpg

Approximate alignment of crossing provided by the City of Sacramento.

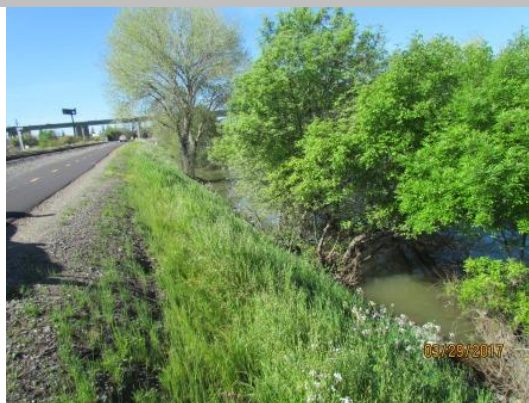
Photo 1 of 1 : SP_2017_NA0005_251_92_20170414_00146.jpg

Tall vegetation on waterside levee slope, blocking visibility. Spring 2017.

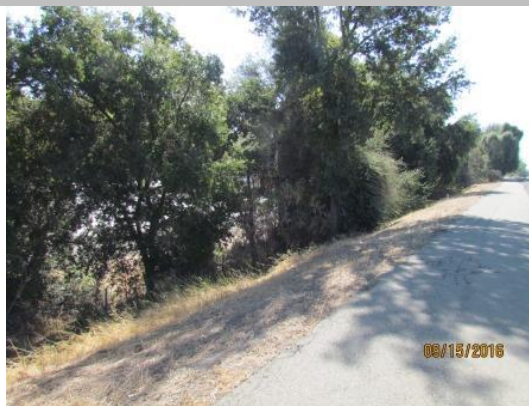
Photo 1 of 1 : SP_2017_NA0005_251_84_20170320_00019.jpg

View of landside slope. Tree trimming and vegetation removal required.
Fall 2016.
